National Transportation Safety Board

Group Chairman's Factual Report

Engineering Group

Conception

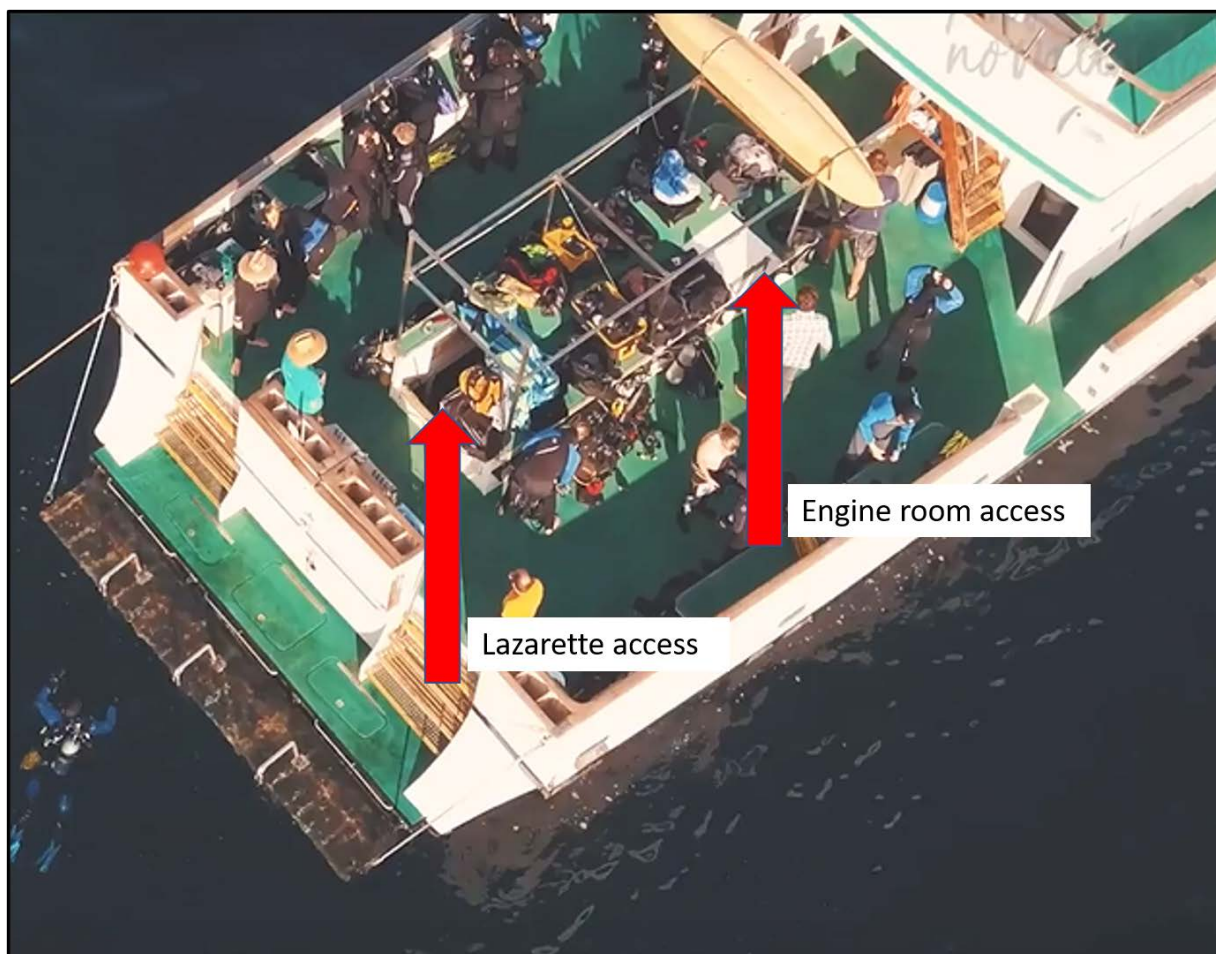
Figure 1. Aft main deck of the *Conception* during a previous voyage. Red arrows indicate access hatches to the engine room and lazarette (Source: Profundo no Mundo, YouTube).

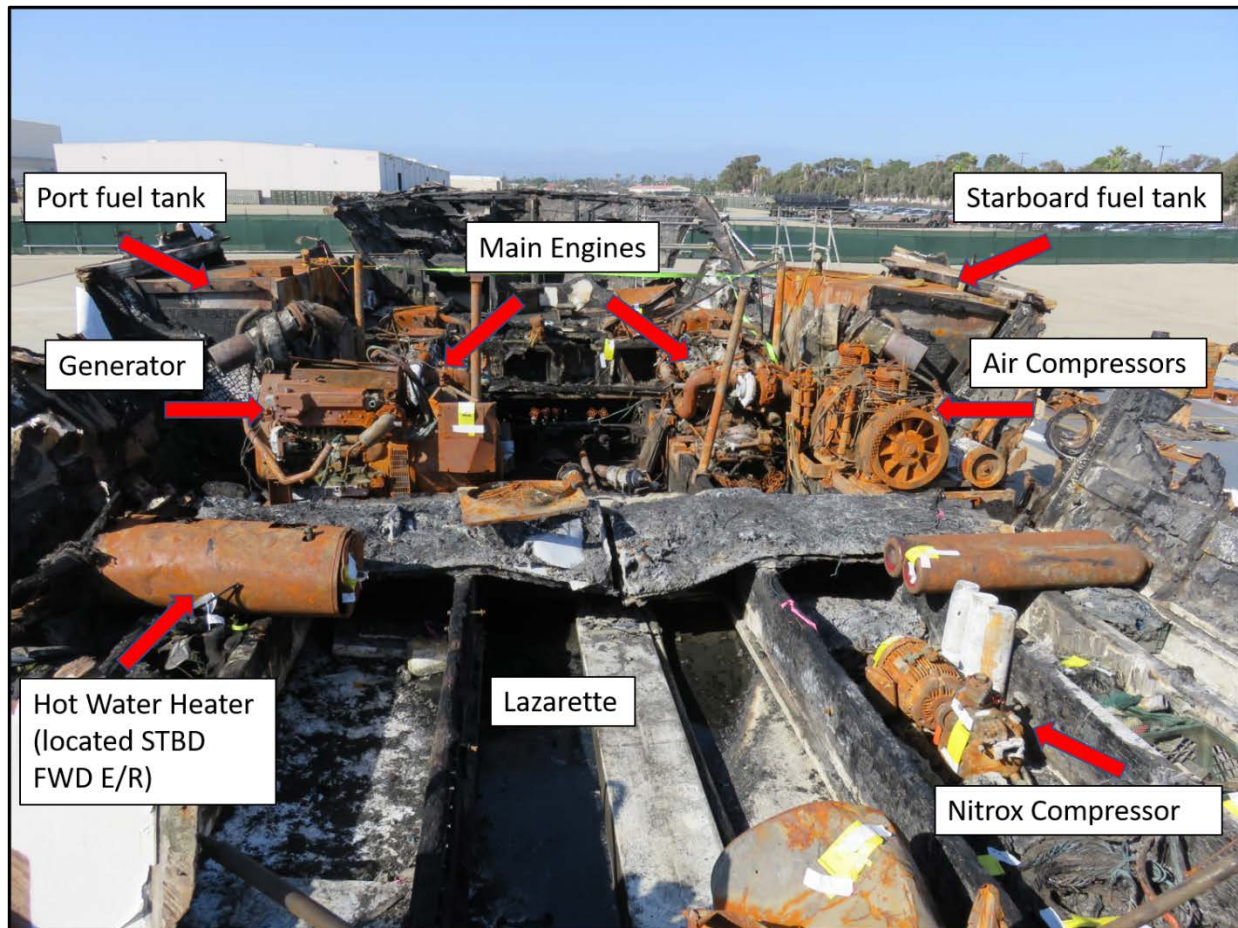
Figure 2. The salvaged hull of the *Conception*, looking from aft to forward, with recovered engine room and lazarette equipment reinstalled.

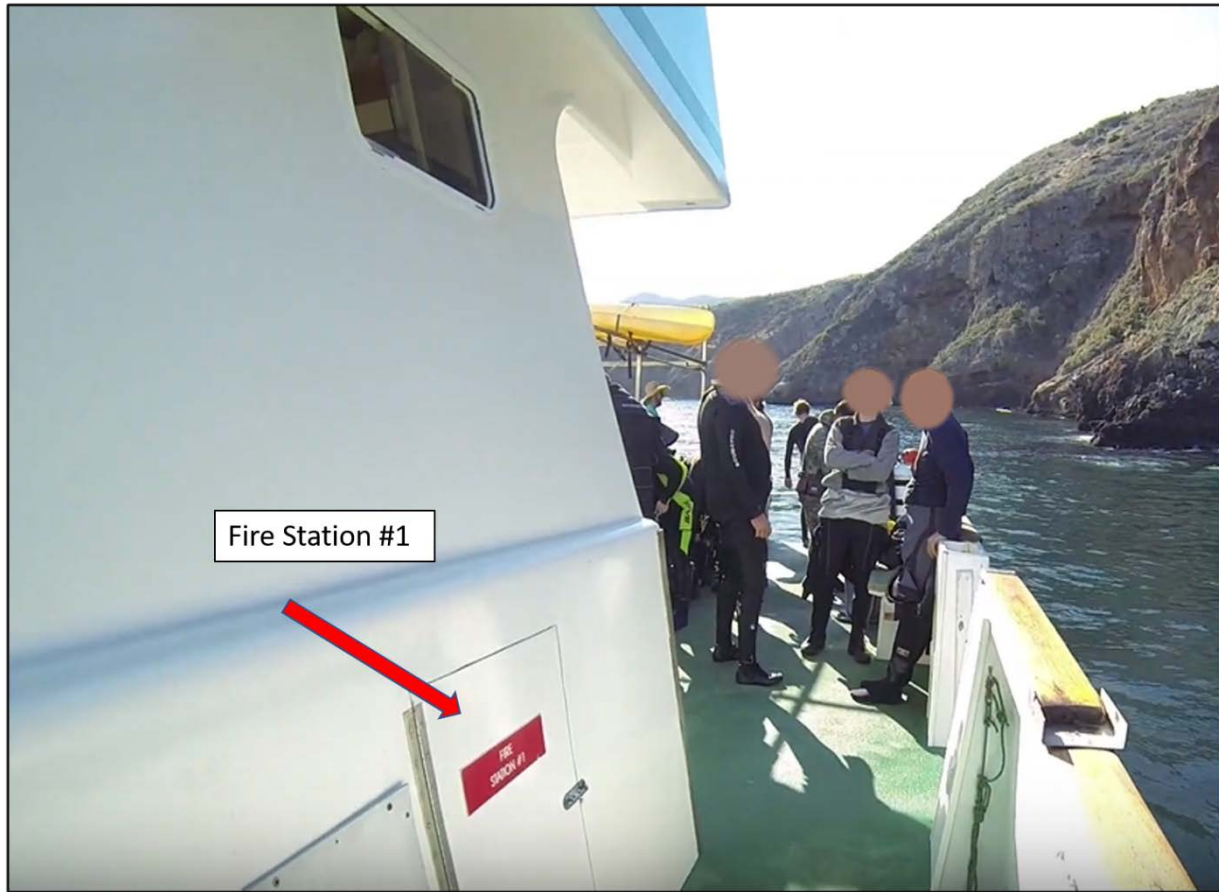
Figure 4. Fire station number one on the *Conception*. Located at the aft end of the galley/salon, outboard on the port side, photo taken on a previous voyage (Sailor James, Youtube).

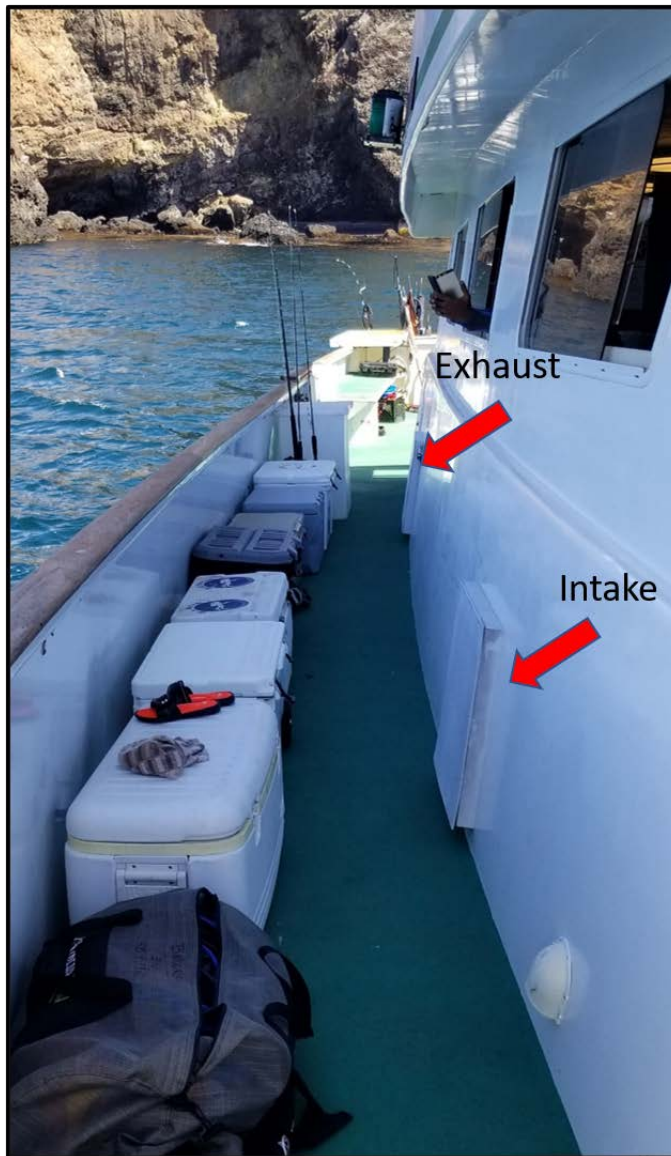
Figure 5. The starboard-side main deck of *Conception*, looking aft from forward of the galley. The red arrows indicate the location of the bunkroom ventilation intake and exhaust ducts. Also note the sliding windows. (Source: R. White).

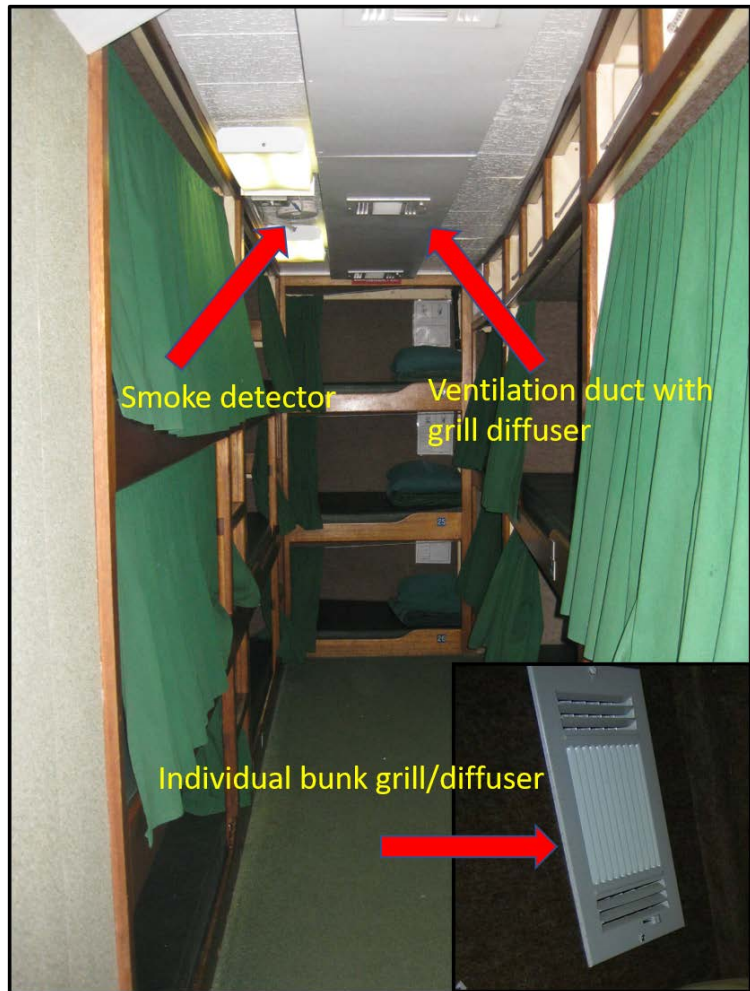
Figure 6. Port side of the *Conception's* bunk room looking aft, with inset of grill/diffuser (Source: Ryan, Inset: Landis).

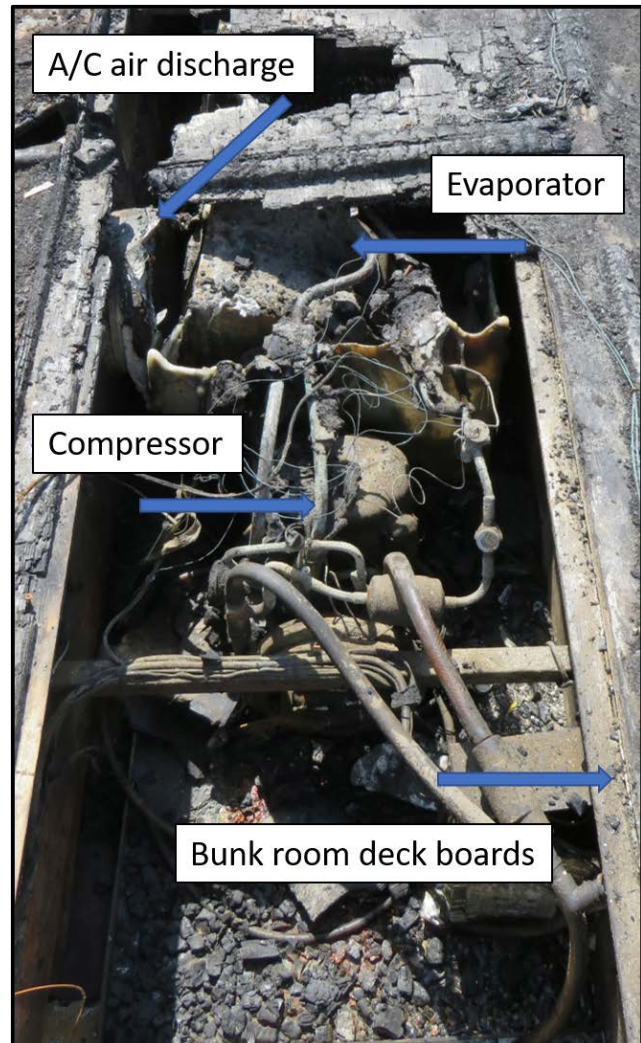
31 The air conditioning unit was recovered still in place in the wreckage and was examined

by investigators. There were no signs of mechanical failure to the components of the unit. The air conditioning system was not connected to the vessel's emergency power. None of the surviving crewmembers turned off the air conditioning system at the time the fire was discovered. The unit would have operated until the *Conception*'s main power was lost (although there was no means to confirm that this occurred).

Figure 7. Post-accident photo of bunk room air conditioning unit located in vessel's bilge area.
